## DAMAGED BUILDINGS NEAR THE MARLIN MINE:

# Preliminary Investigation and Analysis of Building Damage in the Villages of Agel, El Salitre, San José Ixcaniche, and San José Nueva Esperanza, San Miguel Ixtahuacán and Sipacapa Municipalities, San Marcos Department, Guatemala

San Marcos, Guatemala, november 2009

**PRELIMINARY INVESTIGATION AND ANALYSIS OF BUILDING DAMAGE**

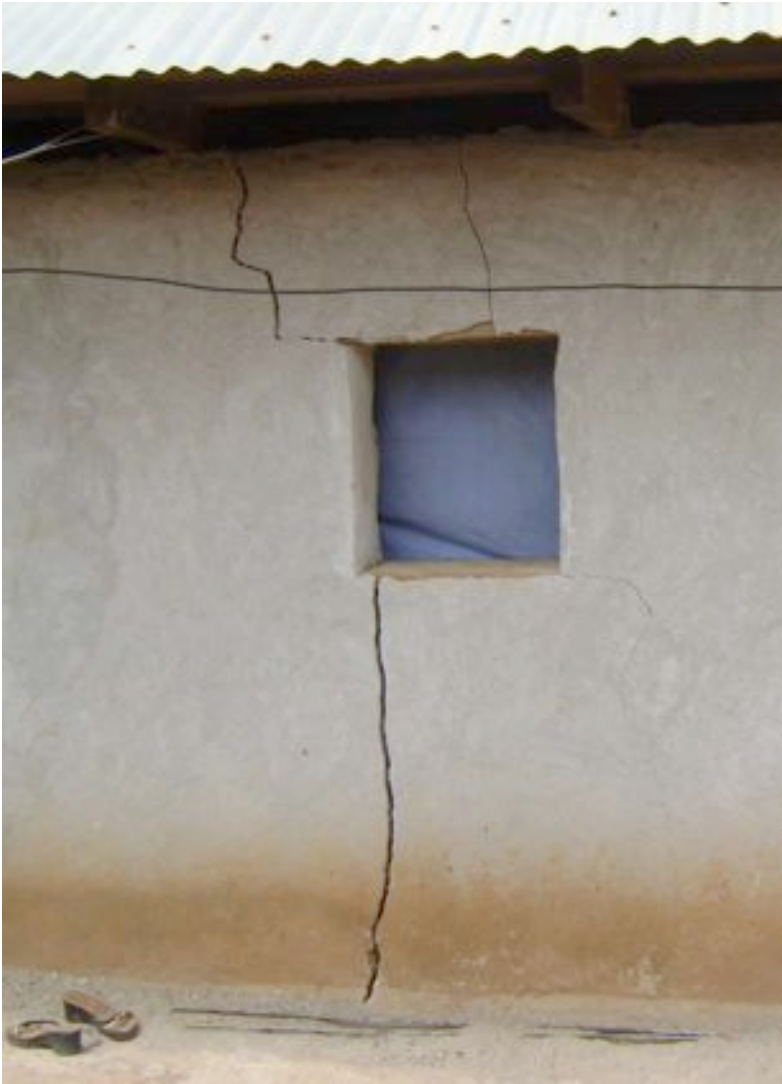
**Figure 1a Vertical Wall Cracks in Adobe**

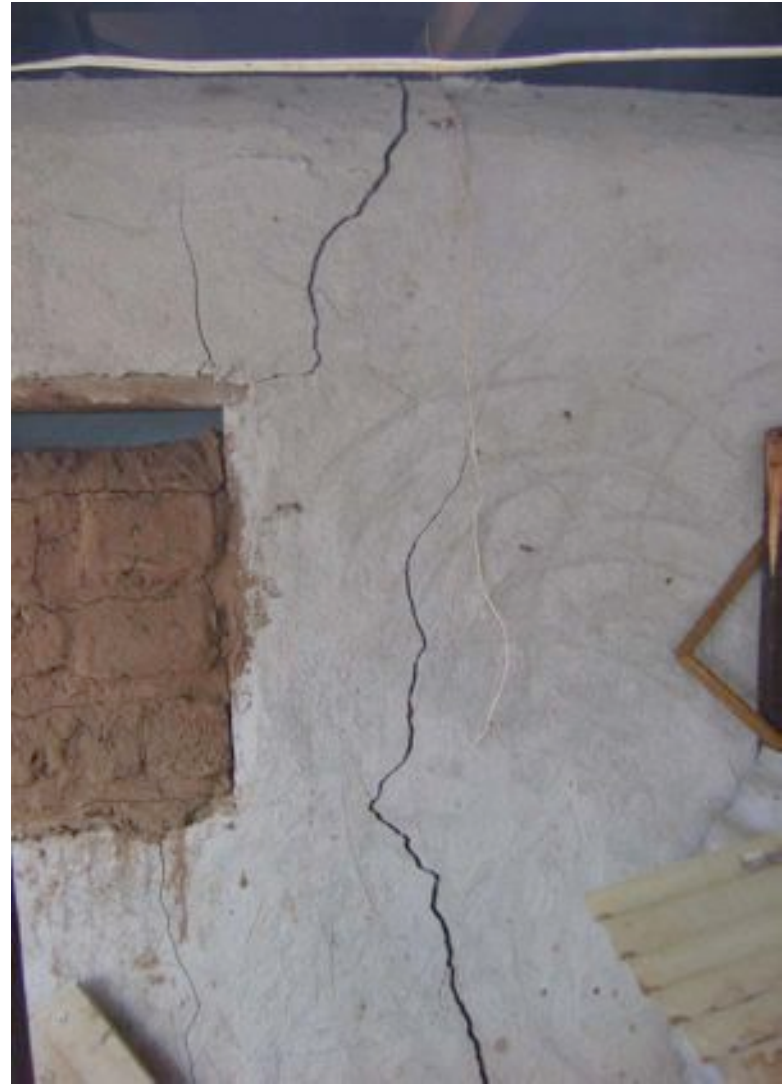
**Figure 1b Vertical Wall Cracks in Adobe**

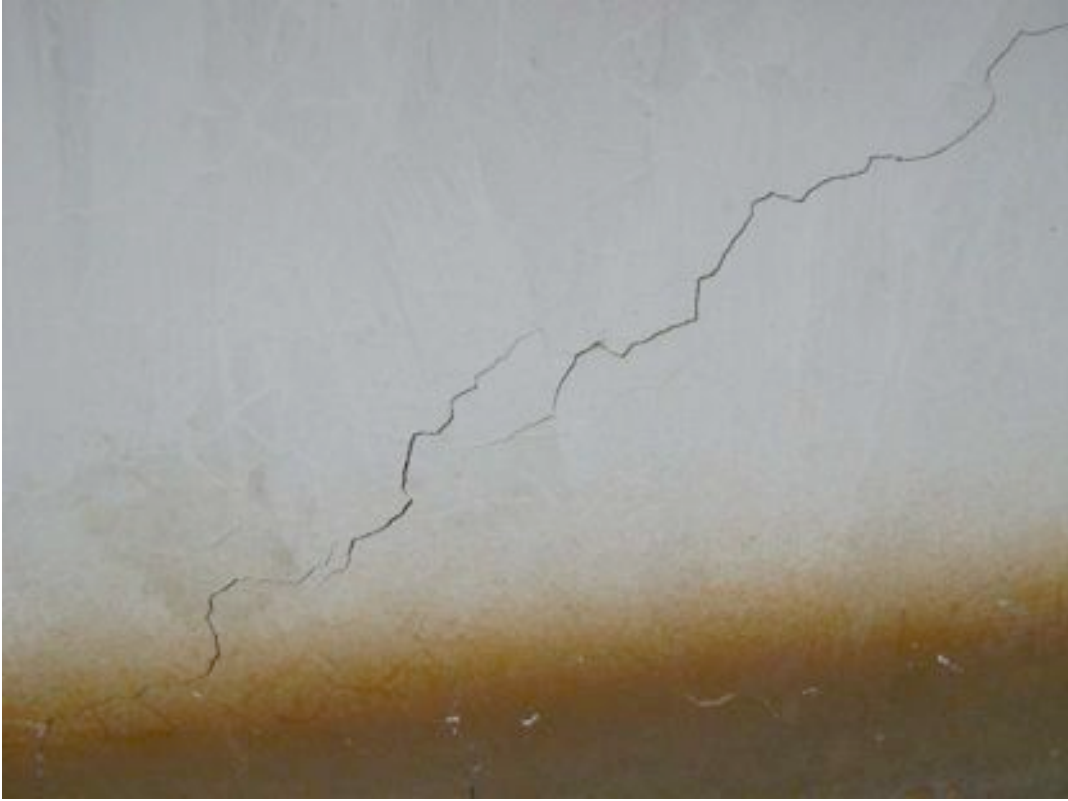
**Figure 1c Incline Wall Crack in Adobe**

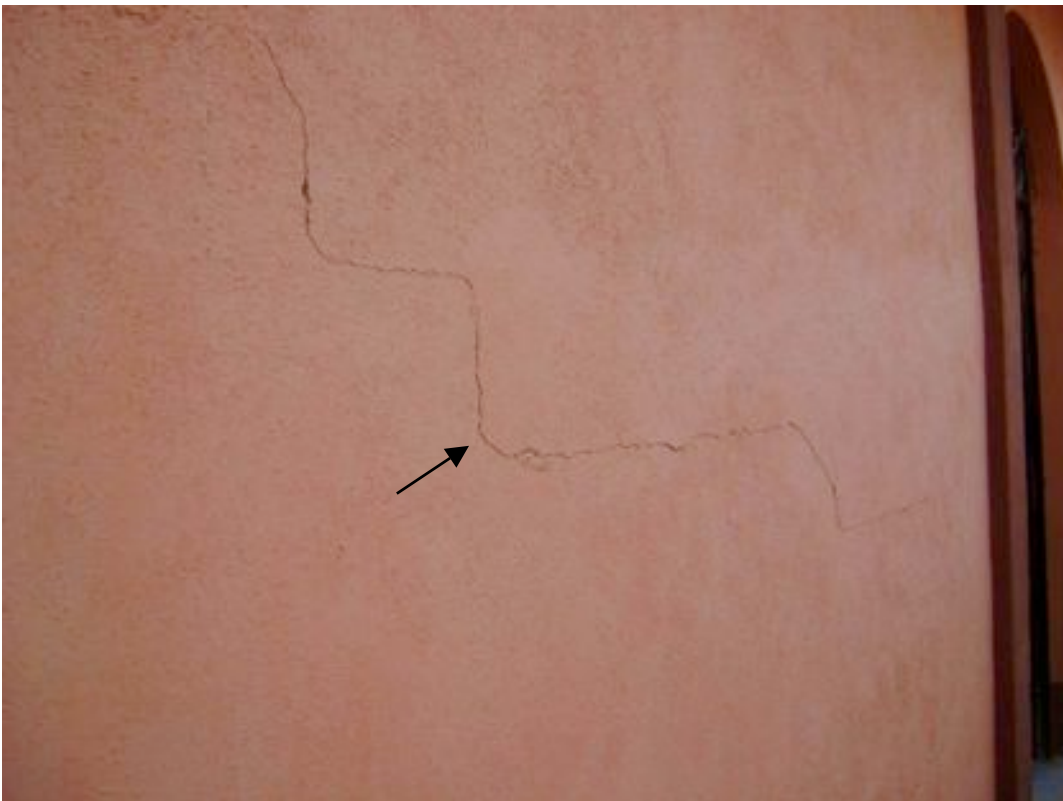
**Figure 1d Crack in Concrete Block Grout**

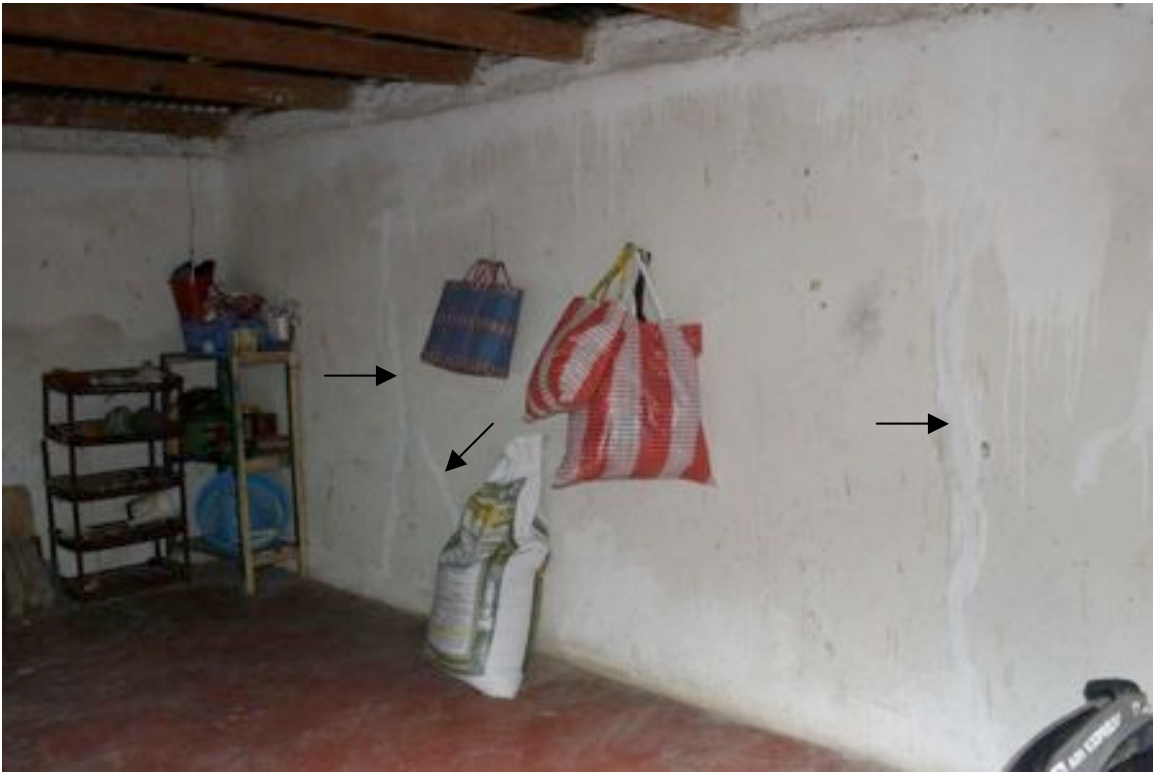
Figure 5a Type 1 Wall Cracks (3 covered with plaster), No Slab Cracks

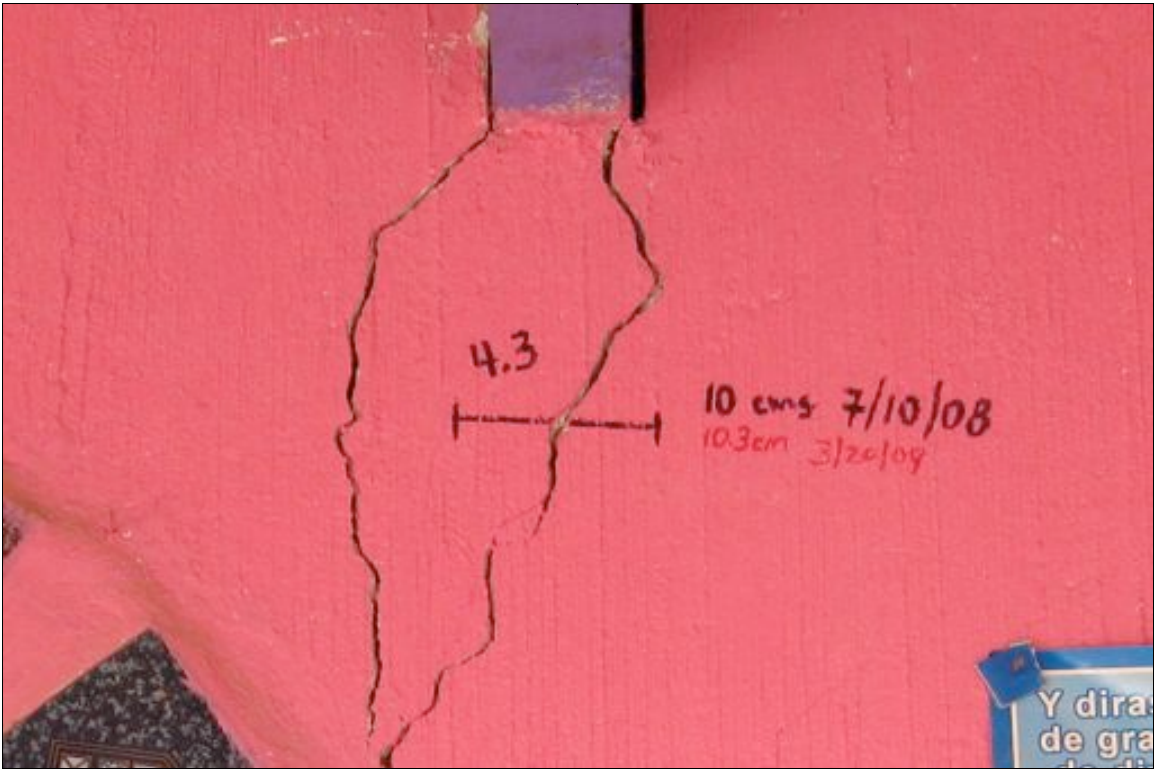
Figure 5b Type 2 Crack from Window or Door to Roof Beam

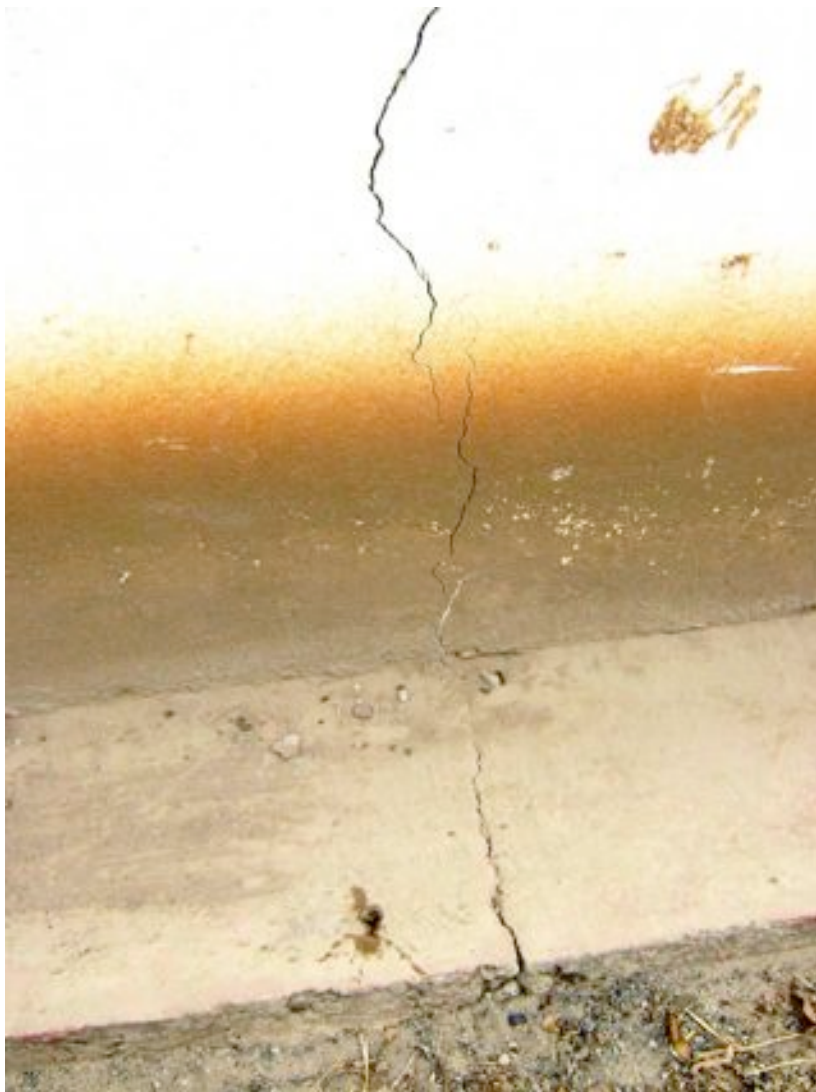
Other floor slab cracks with significant displacement that extend into adjacent walls are generally caused by differential settlement of sub-base, resulting from one or more of the following: poor base compaction, swelling clays, land movements, liquefaction, excessive soil moisture, or ground vibrations. In these cases the wall crack is wider at the top than the bottom.

**Figure 5c Type 3 Crack in Wall and Slab**

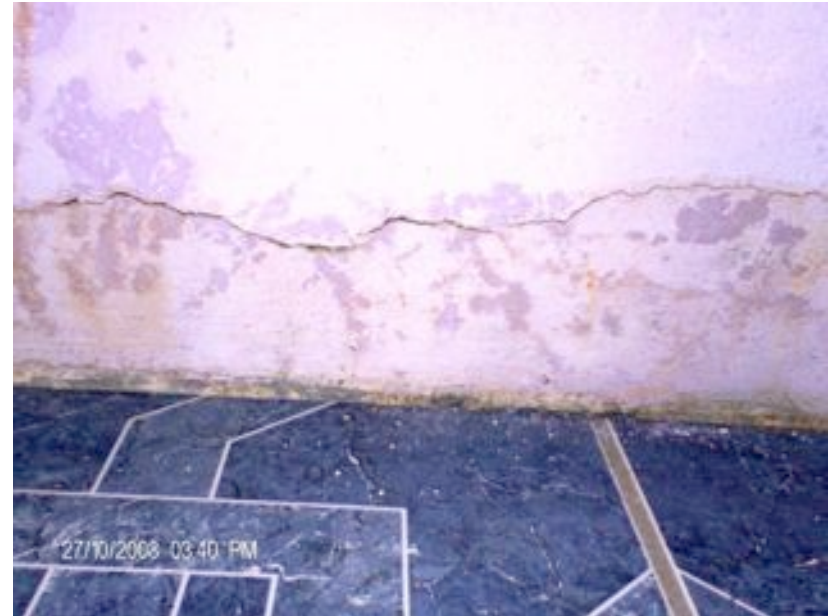
Type 4: A horizontal crack that is usually found at mid-wall in adobe or in the mortar between concrete blocks.

**Figure 5d Type 4 Horizontal Crack**

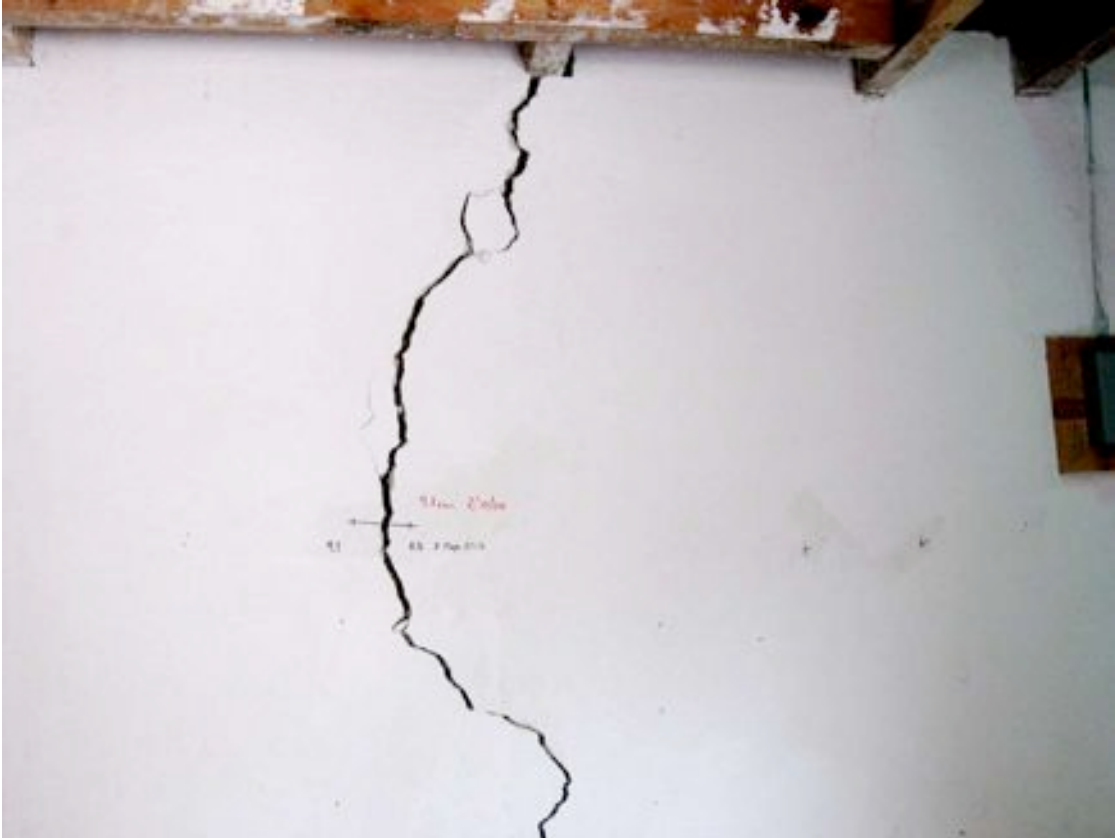
**Figure 5e Type 5 Wall Crack Below Roof Beam**

This type of crack occurs from excessive flexing of the wall caused by vibrations.

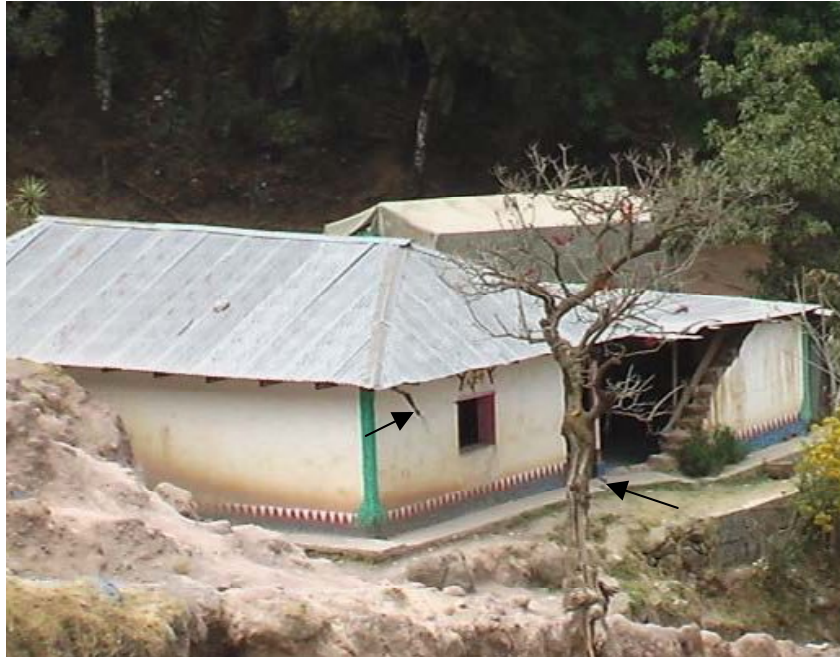
The building in Figure 9 demonstrates damage from landslides. Note the gaping hole in the wall (rubble has been removed), and large crack on the left end. In side there is extensive cracking, heaving, and subsidence of the floor. This subsidence overlies a ground fracture (indicated with arrows) and moisture that extends some 50 meters into an adjacent football field. In the surrounding small valley, the engineering team observed numerous similar fractures. This fracturing is typical of mass land movements. In addition, the team observed other extensive evidence of mass land movement including a 400-meter fracture

**Figure 9a Damaged Building (note hole in wall, left arrow points to wall crack, right arrow points to fracture that extends into foreground)**

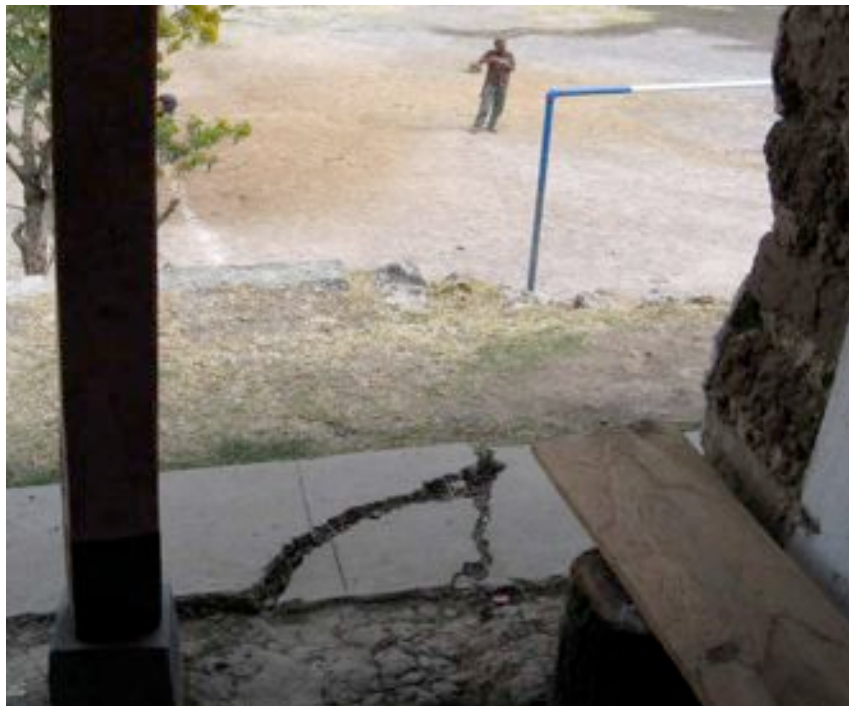
**Figure 9b View From Building in Figure 9a (Fracture in foreground is same one shown in Figure 9a and it extends to person. Fracture difficult to see as it is partially filled with soil)**

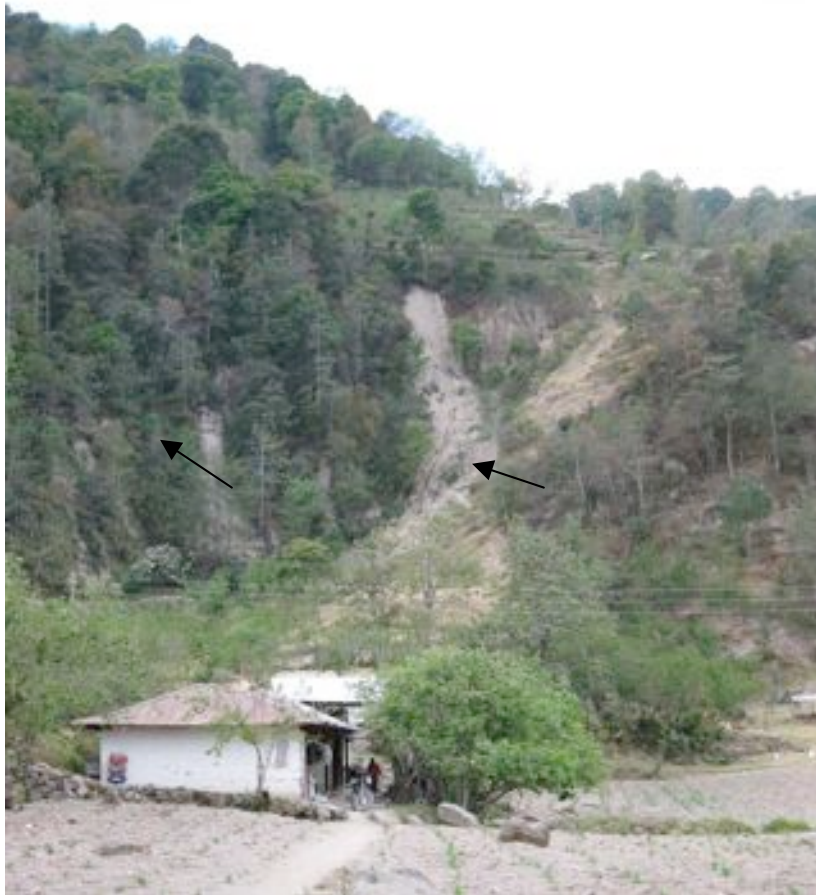
**Figure 9c Escarpment (left arrow) and Recent Landslide (right arrow)**

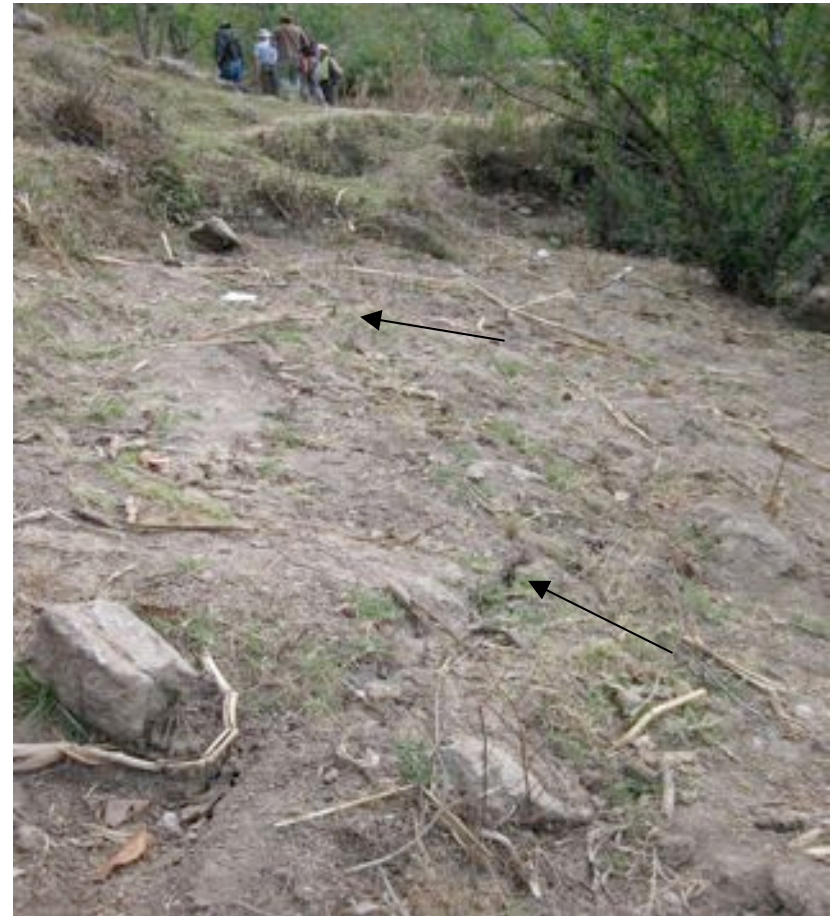
**Figure 9d Arrows Show Part of a Fracture that Is 400 Meters Long**
