## DAMAGED BUILDINGS NEAR THE MARLIN MINE:

# Preliminary Investigation and Analysis of Building Damage in the Villages of Agel, El Salitre, San José Ixcaniche, and San José Nueva Esperanza, San Miguel Ixtahuacán and Sipacapa Municipalities, San Marcos Department, Guatemala

San Marcos, Guatemala, november 2009

**PRELIMINARY INVESTIGATION AND ANALYSIS OF BUILDING DAMAGE**

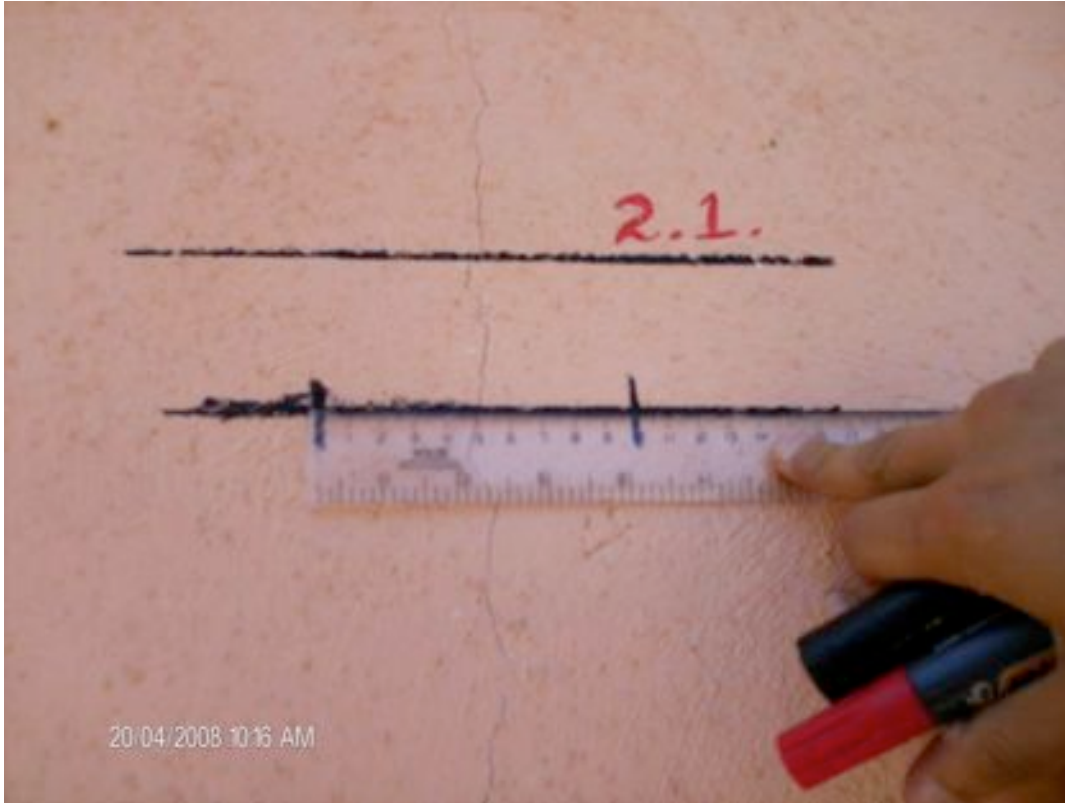
**Figure 6a Measure Crack Width on Upper Line and Measure Width of Tick Marks on Lower Line**

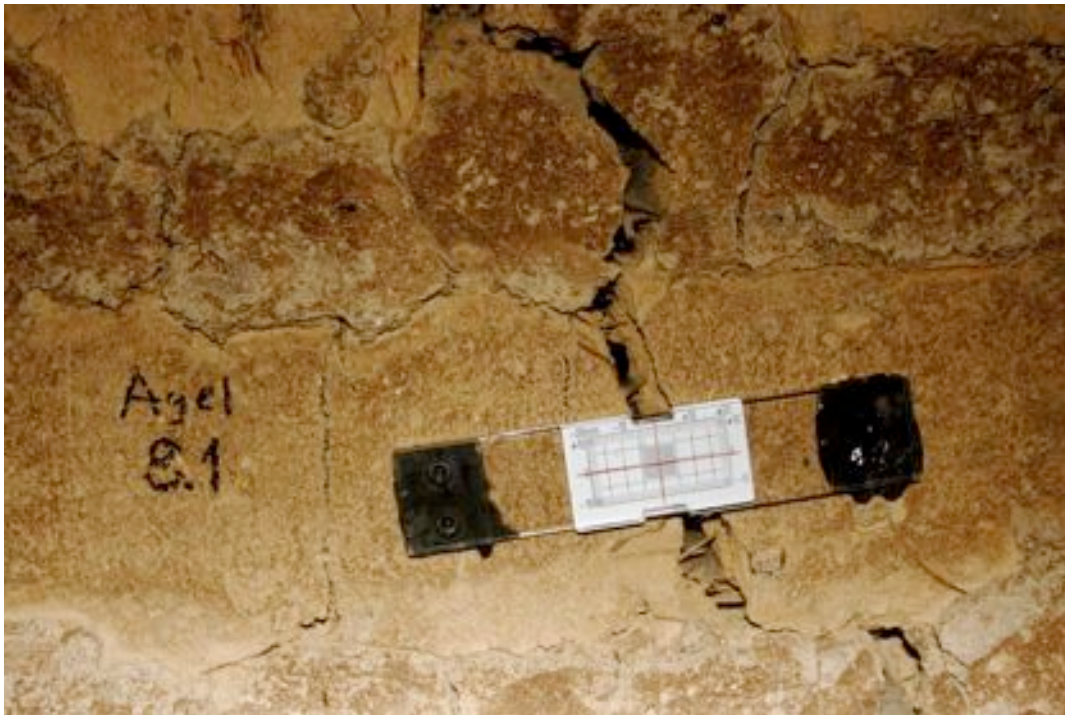
A crack gauge was placed on SJNE 3.1 in addition to the other methods of measurements; however, it was vandalized.

**Figure 6b Crack Gauge**

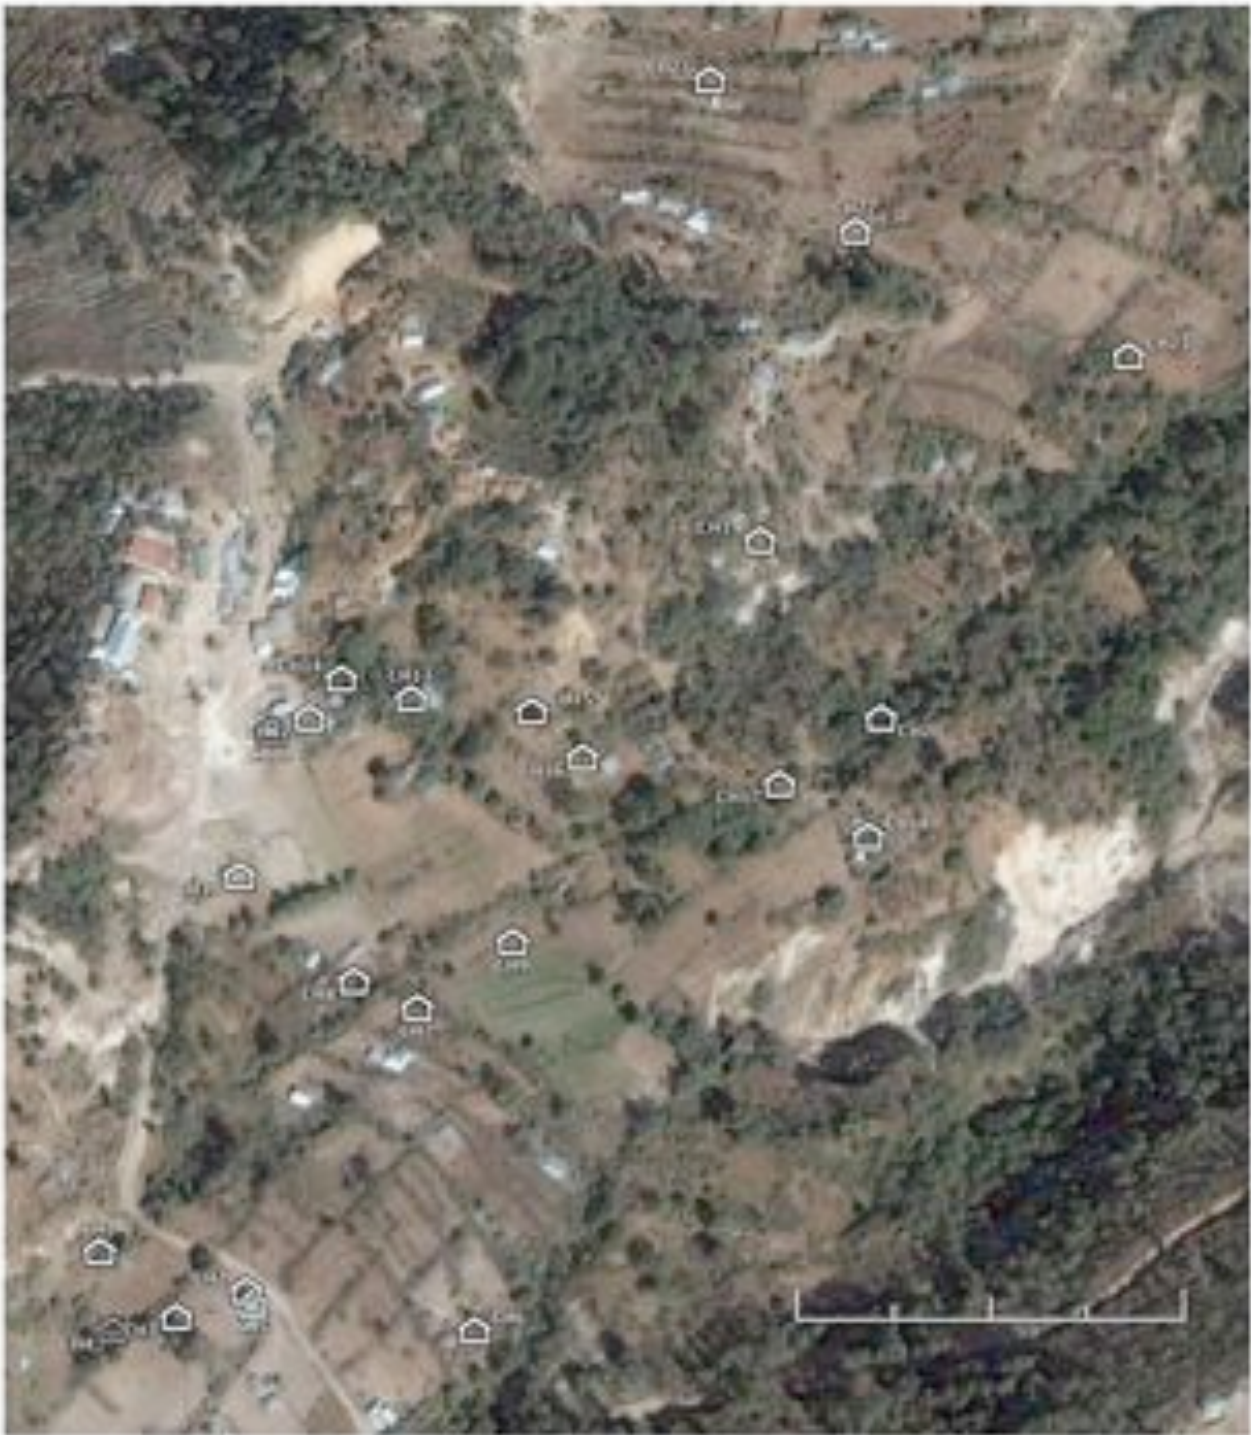
The building in Figure 9 demonstrates damage from landslides. Note the gaping hole in the wall (rubble has been removed), and large crack on the left end. In side there is extensive cracking, heaving, and subsidence of the floor. This subsidence overlies a ground fracture (indicated with arrows) and moisture that extends some 50 meters into an adjacent football field. In the surrounding small valley, the engineering team observed numerous similar fractures. This fracturing is typical of mass land movements. In addition, the team observed other extensive evidence of mass land movement including a 400-meter fracture

**Figure 9a Damaged Building (note hole in wall, left arrow points to wall crack, right arrow points to fracture that extends into foreground)**

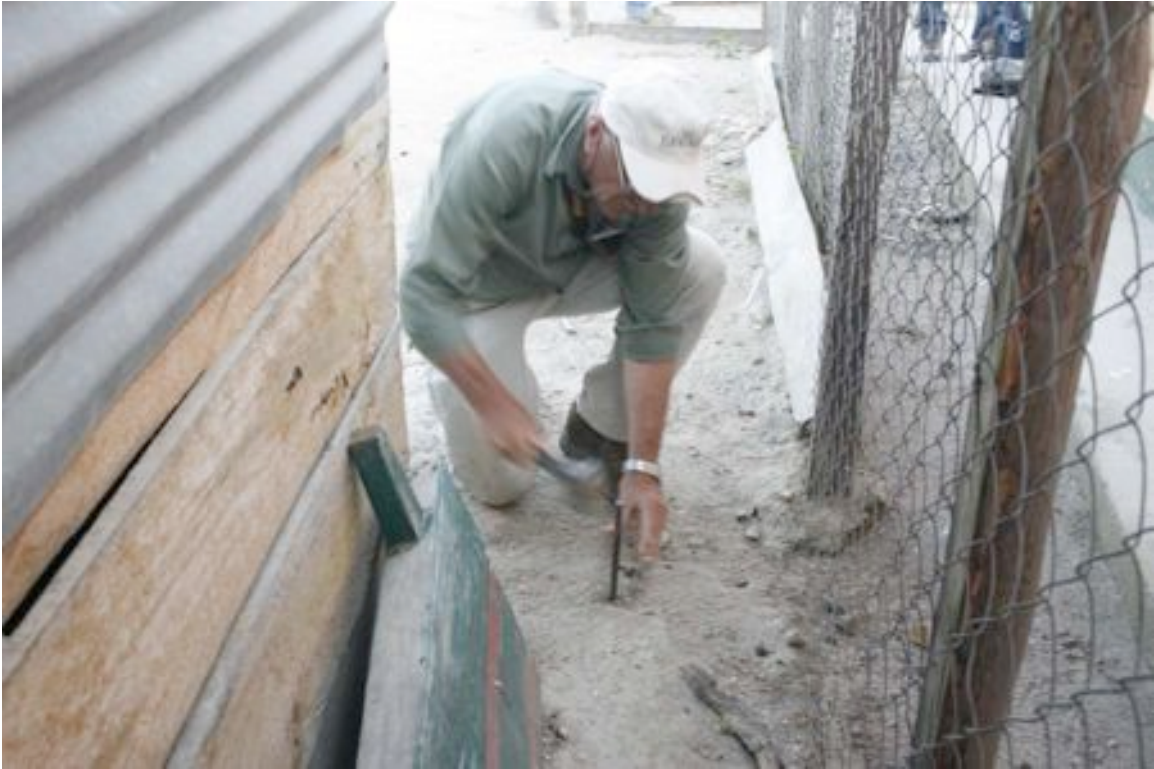
**Figure 11 Field Density Test**

In addition to the lab-testing, a simplified field density test determined the relative density of the soil. The test consists of hammering a 10-millimeter diameter rebar into the ground with a 2.5-kilogram hammer. See Figure 11. The number of blows required to penetrate a given depth was recorded, see last column of Table 4. The test does not give quantitative results, but does generally indicate the relative soil density at the various locations.

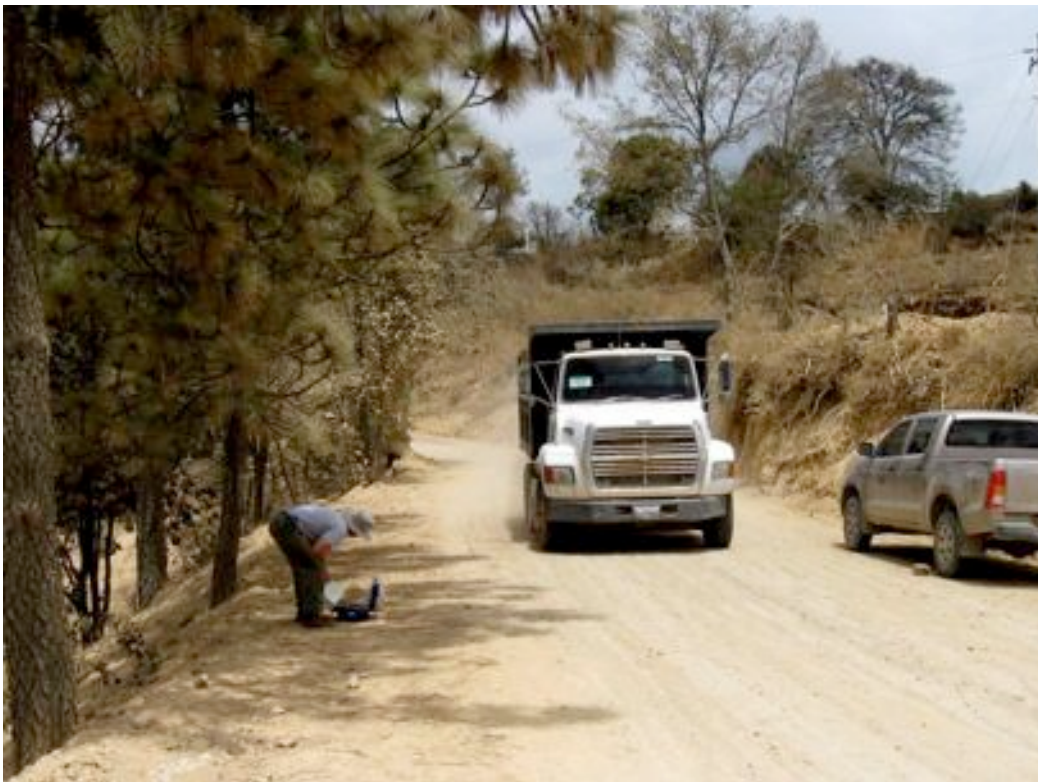
**Figure 12b Monitoring Vehicle Vibrations**

Vehicle vibrations were monitored using an unloaded and loaded Ford three-axle dump truck model Aeromax L9000; as shown in Figure 12. The empty weight of the truck is 13600 kilograms, and the maximum capacity of the truck loaded is approximately 27300 kilograms. This truck is smaller than the largest trucks seen on the road, which were fuel tank trucks. The truck drove past the Blastmate III at various speeds up to 50 kilometers per hour.

The peak particle velocities for the tests are summarized in Table 6, and the Blastmate III detailed results are included in Appendix H. For the unloaded truck moving at a speed of 10 to 30 kilometers per hour, the peak particle velocity remains within a range from 0.238 to 0.349 millimeters per second. The peak particle velocity increases to 0.476 millimeters per second at 40 kilometers per hour, and then more than doubles to 1.16 millimeters per second at 50 kilometers per hour. For the loaded truck at 30 kilometers per hour, vibrations are a maximum peak particle velocity of 0.540 millimeters per second. The loaded truck increases the vibrations 55 percent over the unloaded truck. Road construction underway in Agel prevented additional testing of the loaded truck.
